Manhole Inspection Summary

Manhole # S57E__015MH

Insp Date: **6/30/08 1:44 PM**

Location Address: **4325 e lombard st**

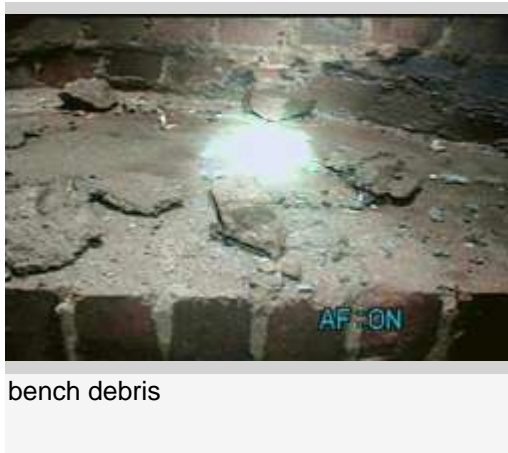
Misc

bench debris

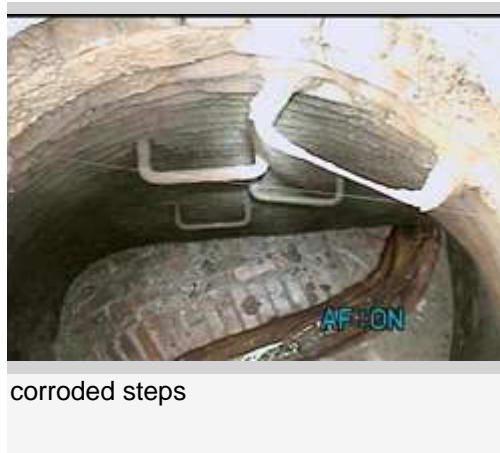
Defect 3

Count: **4** Missing: **0** ☒ **Corroded**

corroded steps

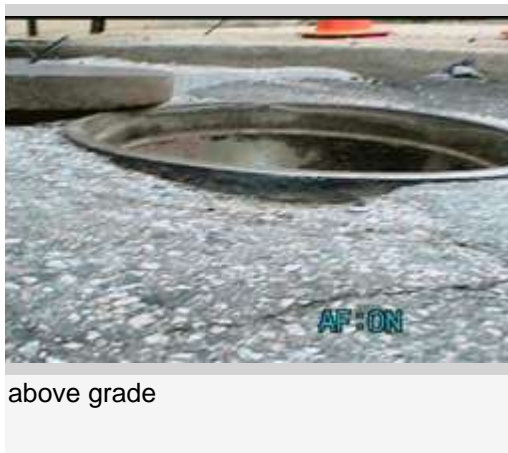
Defect 2

above grade

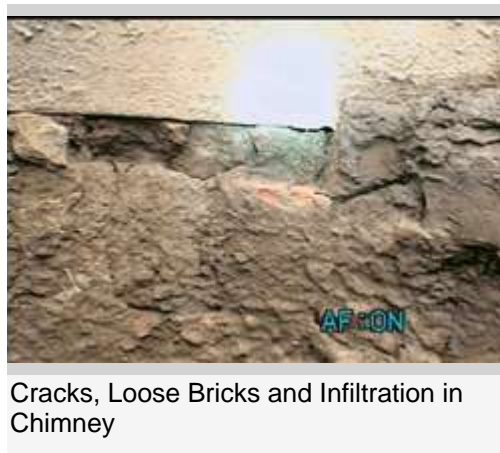
Defect 1

Condition: ☐ Sound ☒ **Cracked** ☐ Root Intrusion ☒ **Loose Brick** ☐ Deteriorated

Infiltration: ☐ None ☒ **Joint** ☐ Cracks ☐ Mortar ☐ Roots ☐ Wall

Cracks, Loose Bricks and Infiltration in Chimney

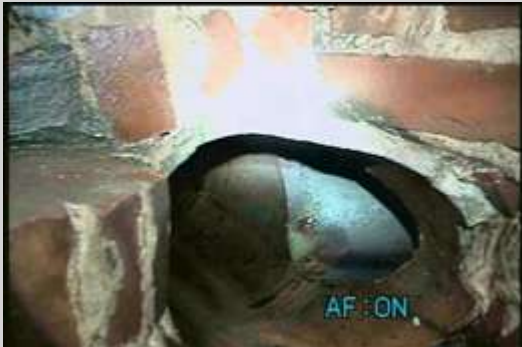
12 O'Clock Outflow

8 in. Circular Gravity Sewer
Pipe Out @ 12 O'Clock

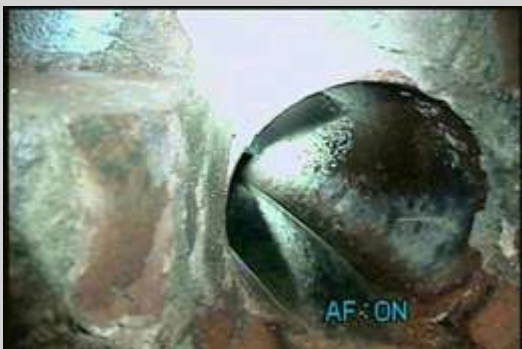
6 O'Clock Inflow

8 in. Circular Gravity Sewer
Pipe In @ 6 O'Clock
